# Manhole Inspection Summary

## Manhole # S31CC\_009MH

Insp Date: **10/30/08 11:02 AM**

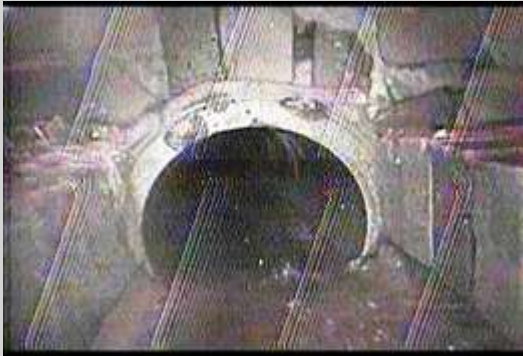
### 8 in. Circular Gravity Sewer Pipe Out @ 12 O'Clock

Rod and Bar (Angled)

Infiltration: **None** Pipe Seal Cond: **Unknown**
